PHASE I INSPECTION REPORT  
NATIONAL DAM SAFETY PROGRAM

**HANSON RESERVOIR DAM  
WHITE SULPHUR SPRINGS, MONTANA  
MEAGHER COUNTY  
MT 3207**

**HKM ASSOCIATES  
BILLINGS, MONTANA**

MARCH 1981

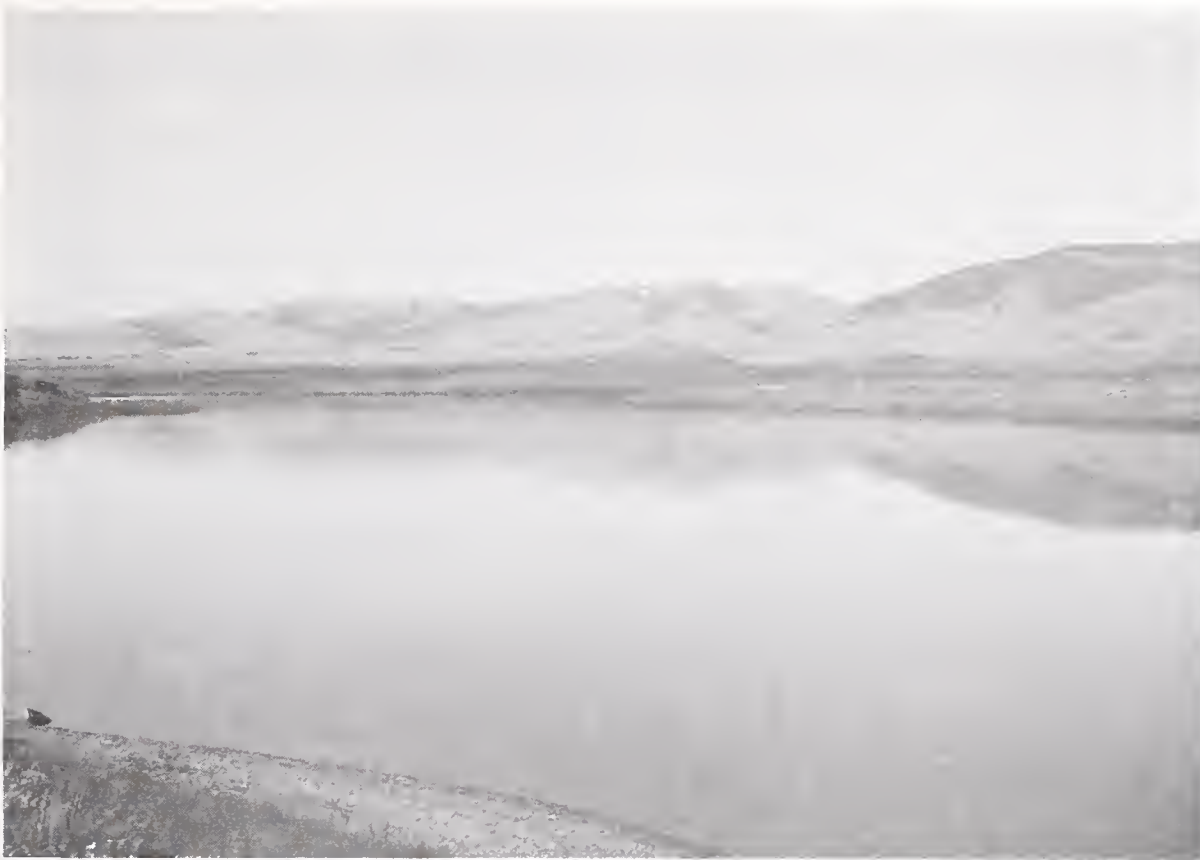
Photo No. 1 - Drainage Basin.  
The drainage basin rises to the foothills  
of the Big Belt Mountains.

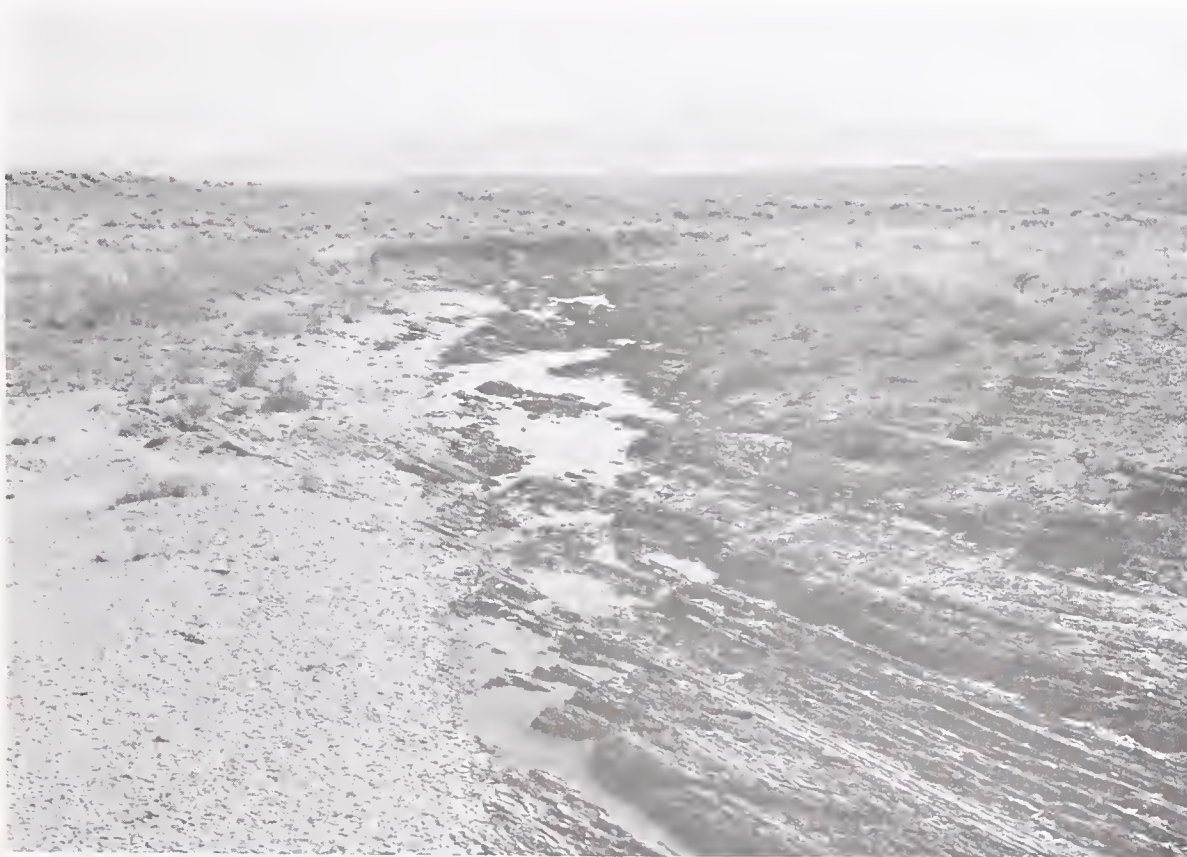
Photo No. 2 - Spillway.  
The spillway transitions from a broad section  
at the crest (bottom of photo) to a narrow  
section where the channel makes a vertical  
drop (top of photo).

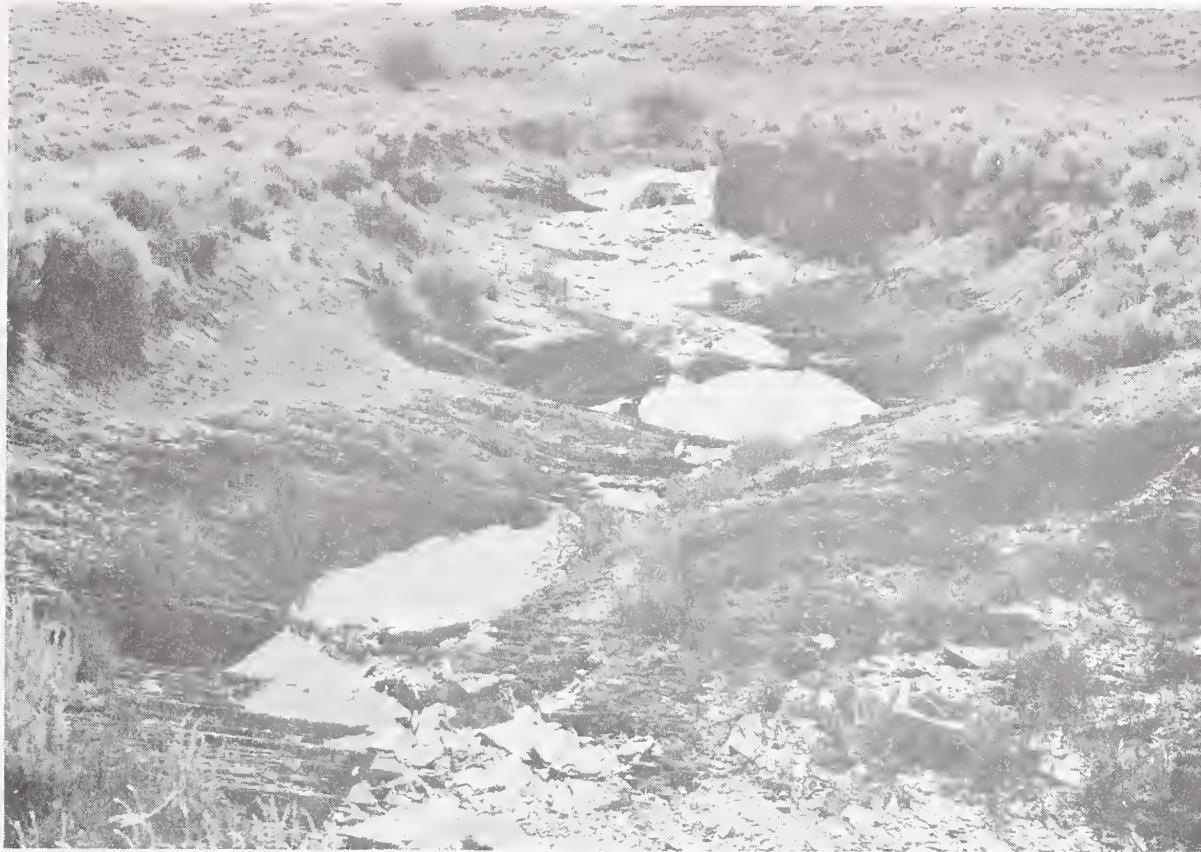
Photo No. 3 - Spillway.  
Downstream of the control (vertical drop)  
the spillway channel banks are oversteepened  
and sloughing.

- (4) Reshape and add rock riprap to the outlet works stilling pool.
- (5) Reshape the spillway channel banks to provide a stable condition.

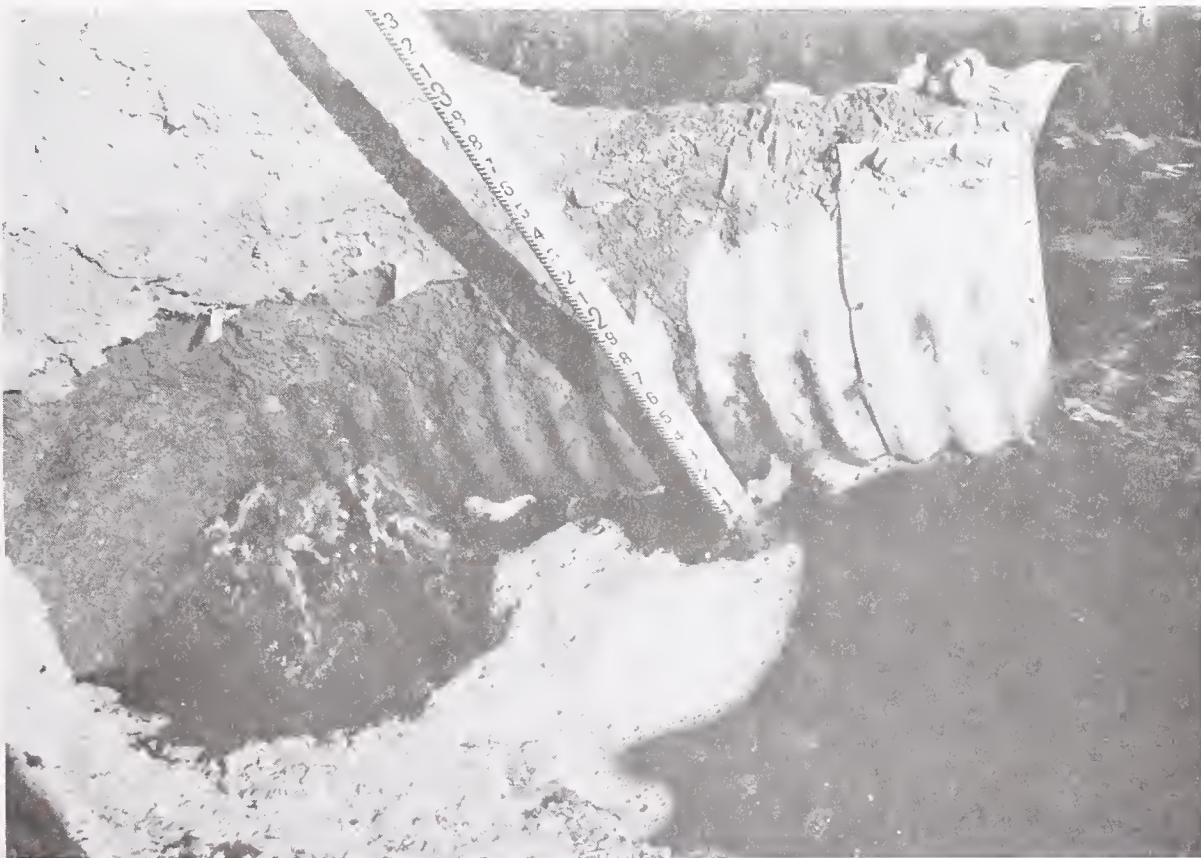
The outlet works is in extremely poor condition. The CSP is severely corroded from the flowline up to about 75 percent of the conduit height (Photo 4 of Appendix B). The embankment is vertical at the outlet, with the top of the pipe 4 feet below the top of the vertical section of the embankment. Severe erosion is occurring below and on both sides of the outlet conduit. Scouring extends approximately 5 feet back into the earth embankment, and extends about 2 to 3 feet on either side of the conduit (Photos 4 and 5 of Appendix B). There is a horseshoe shaped scour hole 3 to 4 feet deep and 3 to 4 feet downstream of the pipe outlet. The apex of the horseshoe is approximately 30 feet from the pipe outlet. The scour hole presently acts as a plunge pool and provides energy dissipation for outlet works flow. Downstream of the plunge pool, the return channel assumes a section 8 to 9 feet wide and generally parabolic in shape with a flow depth of 12 to 24 inches. The channel banks and horizontal alignment are irregular. The overbank areas are relatively flat and covered with a dense mixture of grasses.

Photo No. 4 - Outlet Works.  
The embankment on the right side of the  
outlet pipe is severely eroded, and the  
pipe is corroded and leaking water.

- (2) Immediately lower the reservoir and inspect the entire outlet works facility. Observe caution when using the outlet works, whether it be during normal operation, during passage of flood flows, or during lowering of the pool, so as not to accelerate the deteriorating condition of the conduit. It is recommended that lowering the pool level be performed under the direction of a qualified engineer. The inspection and required replacements/repairs need to be accomplished prior to raising the pool.

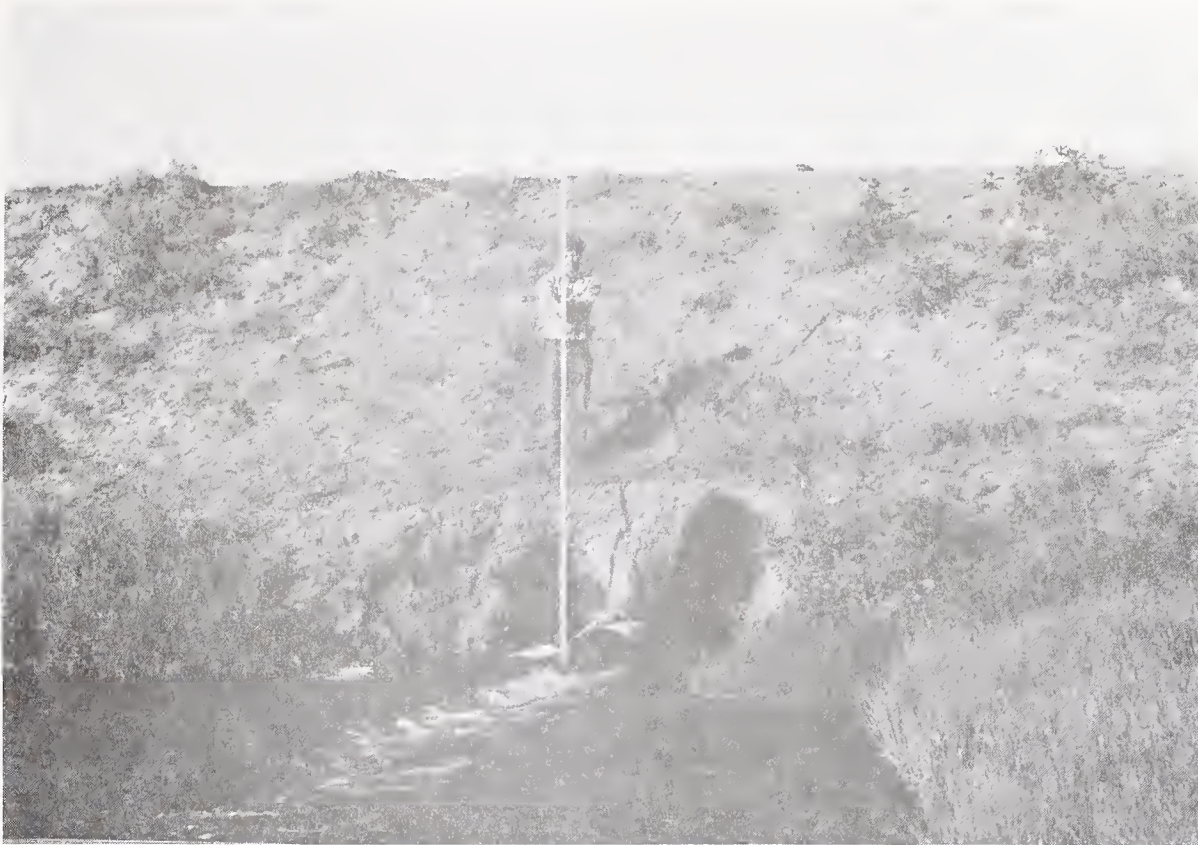
The outlet works is in extremely poor condition. The exposed section of the corrugated steel pipe is severely corroded. Severe erosion around the outlet pipe extends approximately 5 feet back into the earth embankment. There is a 3 to 4 foot deep, horseshoe shaped scour hole 3 to 4 feet downstream of the pipe outlet. Visual inspection indicated the gate stem was in approximately the closed position, yet the outlet pipe was flowing half full at the exit. The gate stem was bent which probably explains the inability to get a complete seal at the gate.

Photo No. 5 - Outlet Works.  
Severe embankment erosion is occurring around the outlet pipe. The pipe is flowing half full with the operating gate valve stem slightly open.

- (3) Perform the following repairs on the embankment: reconstruct the upstream face and dam crest to provide a minimum crest width of 12 feet; place a weather resistant rock riprap material and bedding material, as required, on the upstream face; regrade the downstream face to provide uniform stable slopes, repair cattle damage and revegetate; repair the eroded area at the embankment toe where the outlet works exits with a rock backfill.

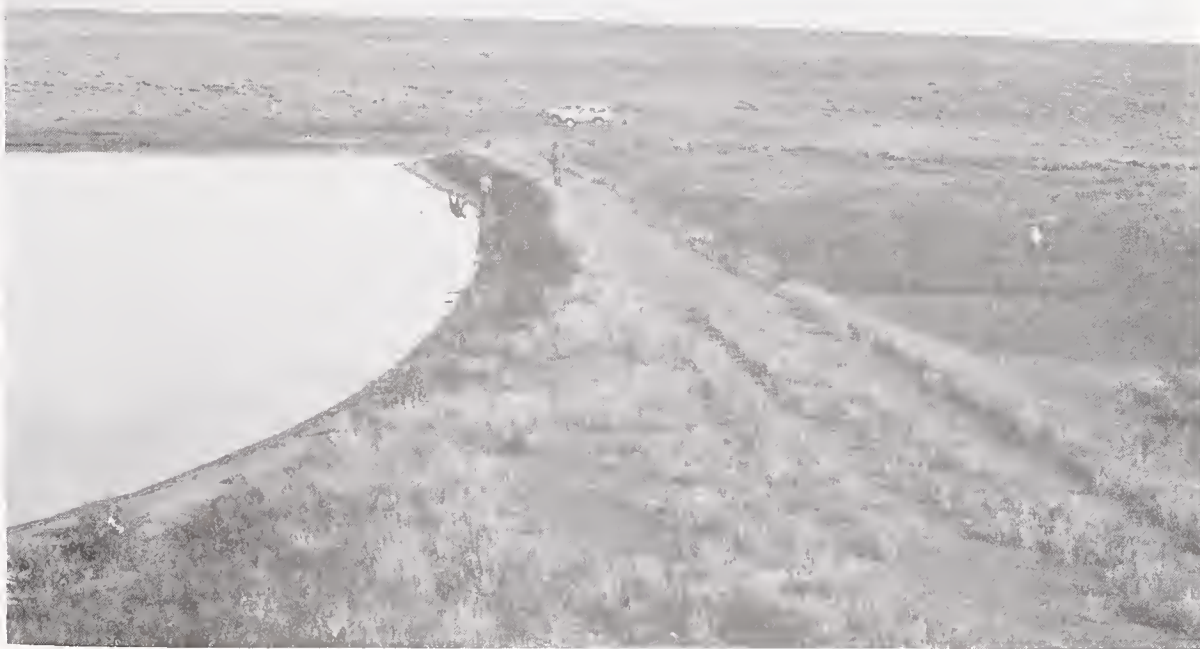
Photo No. 7 - Dam Embankment.  
Shown is the dam embankment looking towards  
the west.

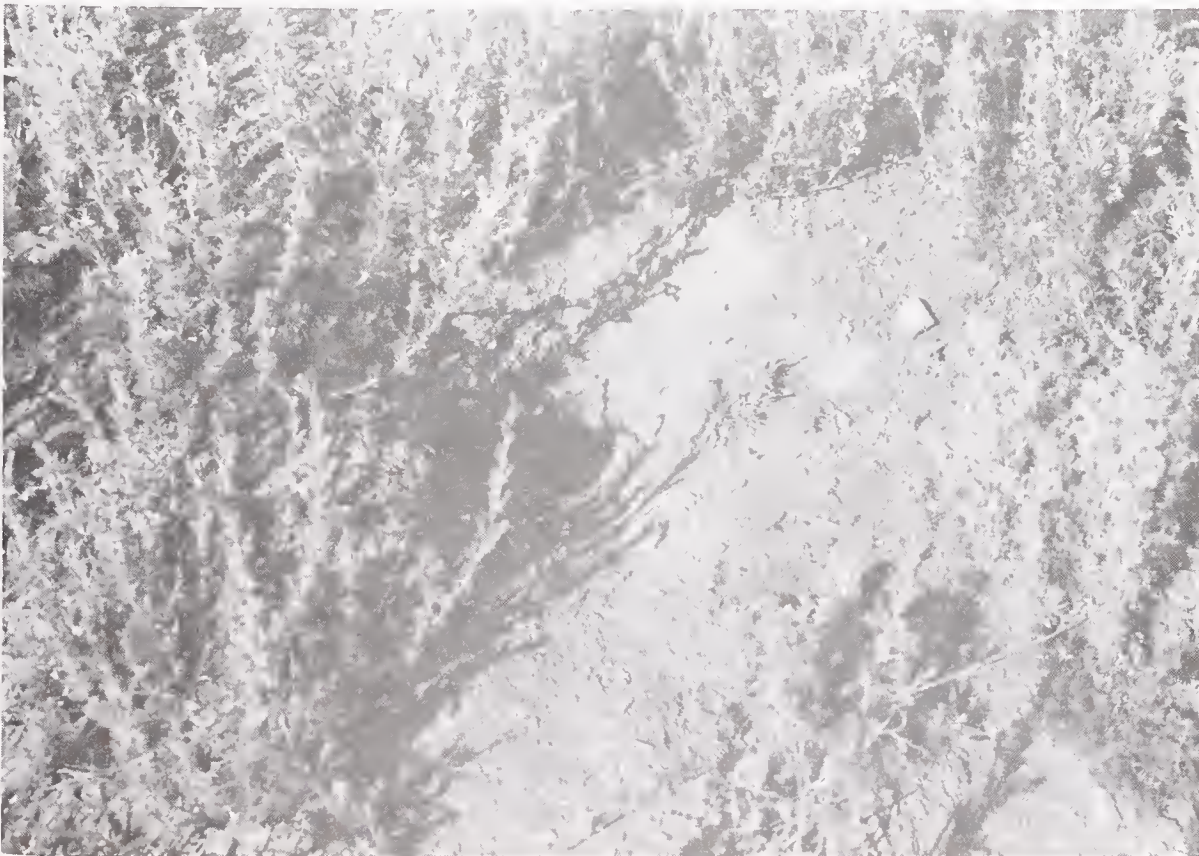
Photo No. 8 - Dam Embankment.  
Rodent holes exist throughout the dam  
embankment.

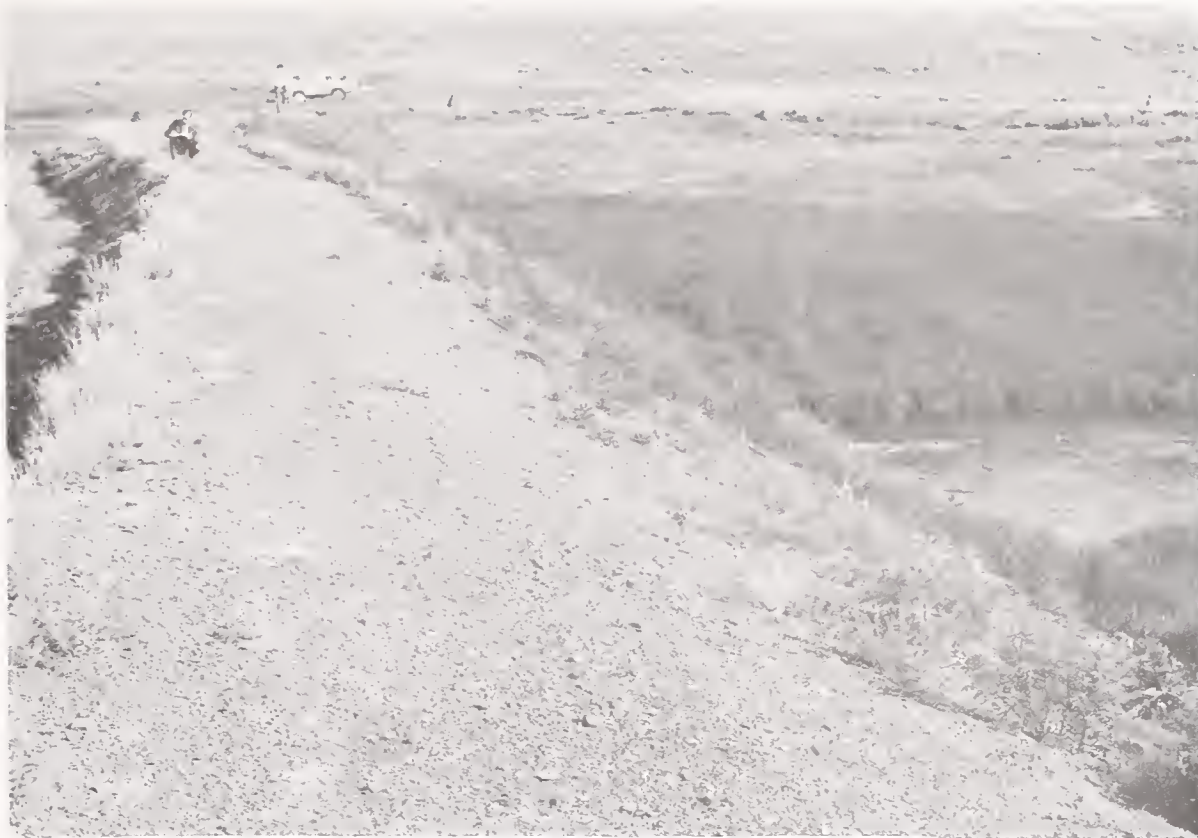
Photo No. 9 - Dam Embankment.  
The dam embankment is shown looking  
westerly.

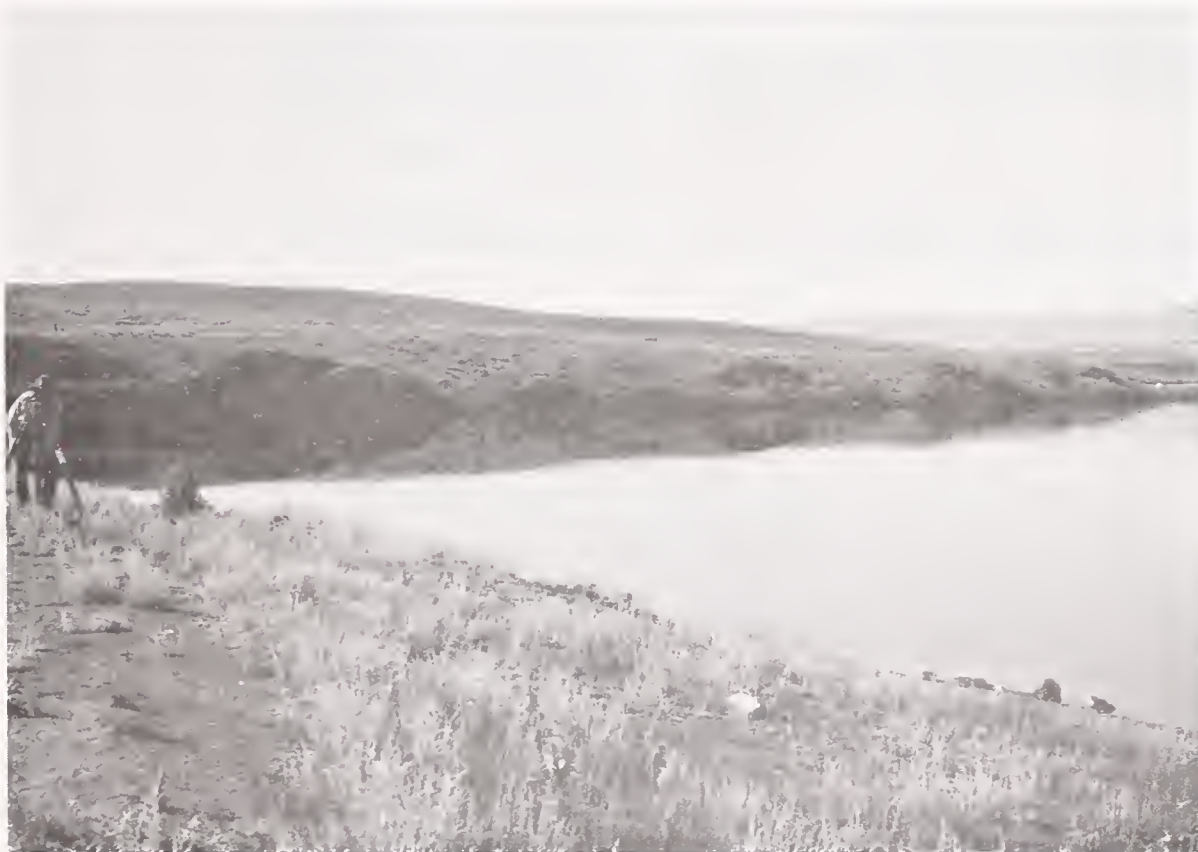
The reservoir shorelines are considered to be in stable condition as no major slides or scarpments were observed. The shoreline is occasionally vertical, or near vertical, and localized sloughing

occurs due to wave action and saturated conditions (Photo 10 of Appendix B).

Photo No. 10 - Reservoir Basin.  
Shown are the steep banks along the  
reservoir pool.
